Alternative Treatments for At-Grade Pedestrian Crossings

IN RESPONSE TO A GROWING NEED FOR BETTER INFORMATION ON PEDESTRIAN CROSSING TREATMENTS TO BE COMPILED INTO A SINGLE COMPREHENSIVE DOCUMENT, THE ITE PEDESTRIAN AND BICYCLE TASK FORCE PREPARED AN INFORMATIONAL REPORT ON ALTERNATIVE TREATMENTS FOR PEDESTRIAN CROSSINGS, WHICH IS SUMMARIZED HERE.

**BY THE ITE PEDESTRIAN AND BICYCLE TASK FORCE,
NAZIR LALANI, CHAIR**

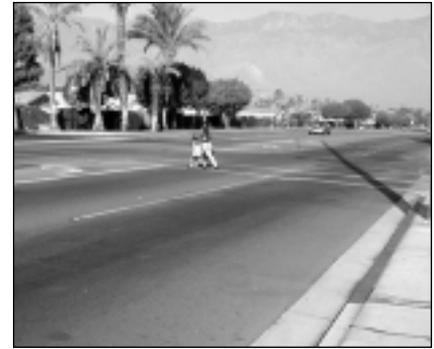
Figure 1. Pedestrian crossing using traditional treatments in the United States. Crosswalk is striped with 12-in. white lines and posted with the standard signs.

For many years, marked crosswalks were installed with the minimum amount of signing and striping as illustrated in Figure 1. This approach does not provide warning of the possibility of crossing pedestrians, especially if paint-based markings are used as opposed to thermoplastic materials. ITE's *Recommended Practice for the Design and Safety of Pedestrian Facilities*³ provides guidance on pedestrian crossings and describes some of the treatments that can improve safety for pedestrians using marked crosswalks.

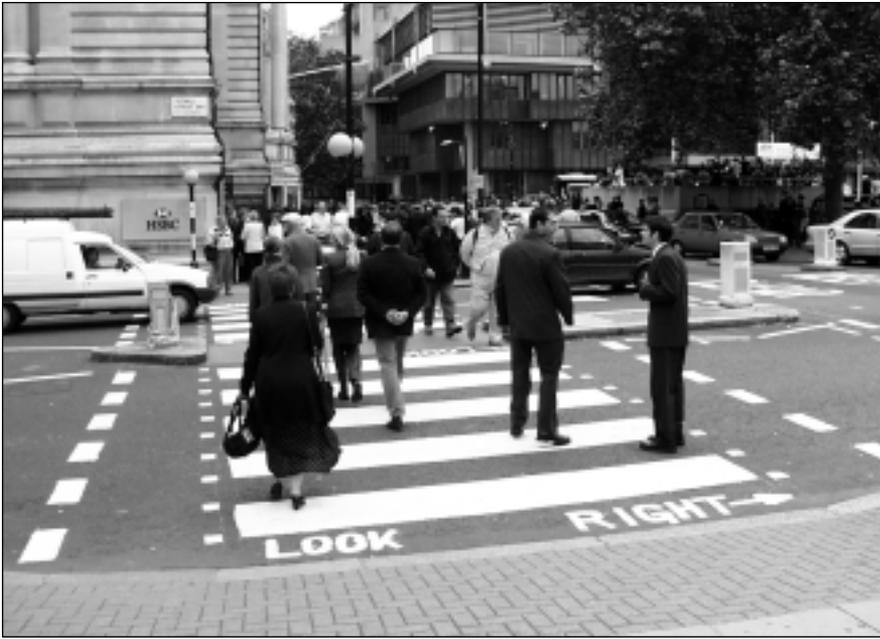
Figure 2. Uncontrolled pedestrian crossing in the United Kingdom includes refuge, flashing beacon, high visibility markings and pavement legends.

Figure 2 shows an example of a pedestrian crossing in the United Kingdom that includes high visibility markings, a refuge island, flashing beacons and pavement legends for pedestrians.

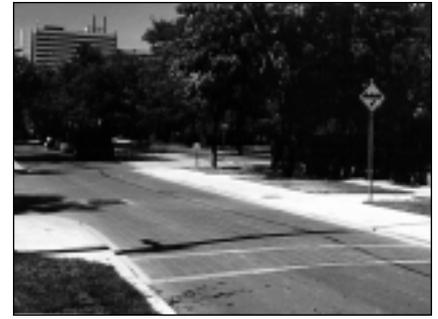
Figure 3. Raised intersection in Canada.

ITE's publication entitled *Traffic Calming, State of the Practice*⁴ provides a comprehensive catalogue of residential street treatments. Figure 3 shows a site in Canada where a raised intersection has been constructed.

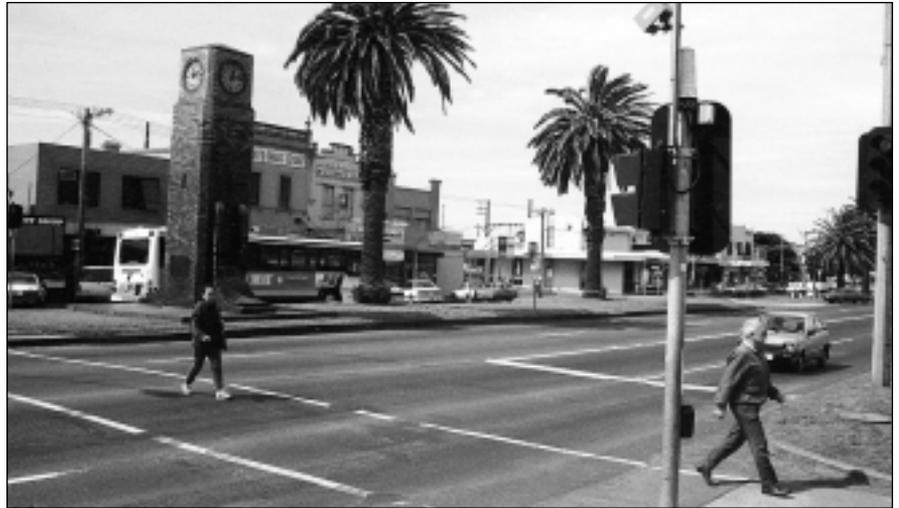
Figure 4. Puffin crossing in Australia.

Figure 4 shows a site in Australia where a Puffin crossing is located.

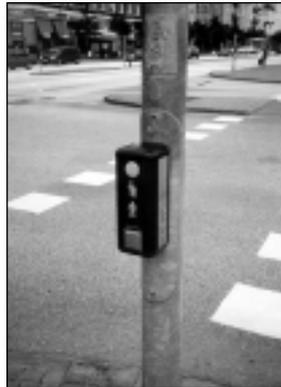
Figure 5. Pushbutton with tactile map on the side includes sound generator, tactile map, LED light and vibrating hardware for accessibility.

Figure 5 shows a site in Denmark, where a pushbutton with a tactile map is used.

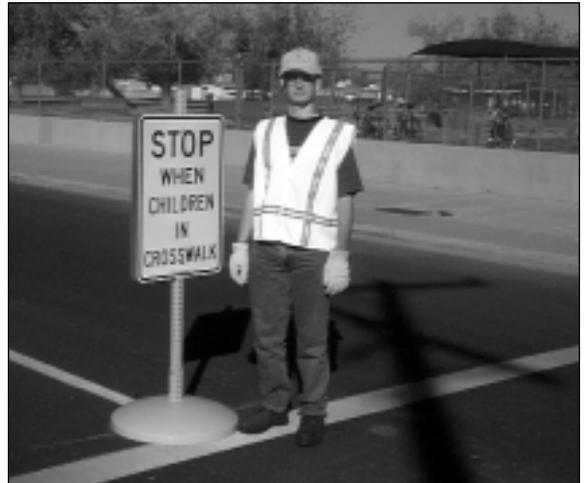
Figure 6. Portable sign at school crosswalk in Arizona.

Figure 6 shows a portable sign used at school crosswalks in Arizona, USA.
